CITY OF AMARILLO

Asset Management Plan

2019

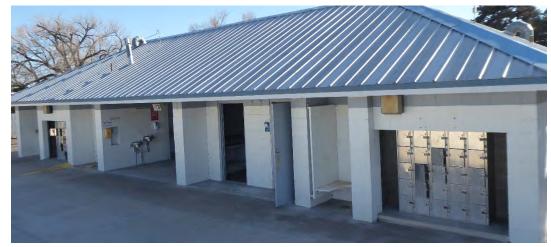
Thompson Pool was shut down due to structural, health and safety, and economic factors. The facility posed enormous risk to human life and well-being for the pool visitors and operators, and it had become more of a liability rather than an asset.
