CITY OF AMARILLO

Asset Management Plan

2019

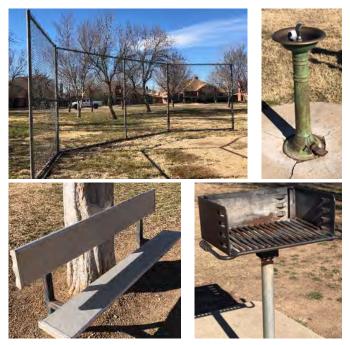
The following table summarizes the immediate replacement needs for the City-owned assets at Arden Road School Park.

Description	Cost
Backstop	\$20,000
Barbeque Grill	\$160
Bench	\$1,500
Concrete Pad	\$1,034
Drinking Fountain	\$4,000
Lighting	\$17,500
Pet Waste Station	\$200
Picnic Table	\$1,200
Signage	\$1,000
Trash Can	\$250
Restroom - Breaker Panel	\$2,000
Restroom - Exterior Lighting	\$200
Total	\$49,044

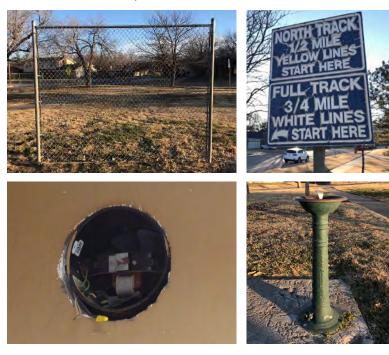
The following table summarizes the immediate replacement needs for the City-owned assets at Belmar School Park.

Description	Cost
Backstop	\$20,000
Bench	\$500
Concrete Pad	\$115
Dedication Plaque	\$2,500
Drinking Fountain	\$8,000
Fencing	\$667
Monument	\$3,000
Mulch	\$1,763
Pet Waste Station	\$200
Signage	\$1,500
Trash Can	\$250
Restroom - Exhaust Fan	\$600
Total	\$39,096
